TECHNICAL SUPPORT BULLETIN

TSB 2020-004 – IoT 1.5 Upgrade and Insufficient Licenses

PRODUCTS AFFECTED: RUCKUS IOT

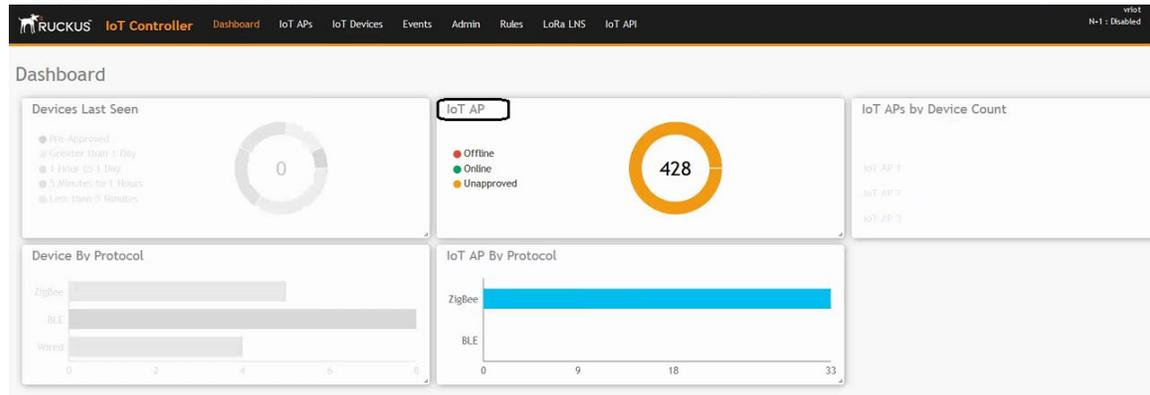
Total AP's on IOT controller

According to above scenario, only 85 AP's can be managed by the IOT Controller.
